# Pipeline infrastructure in the Netherlands

### Summary

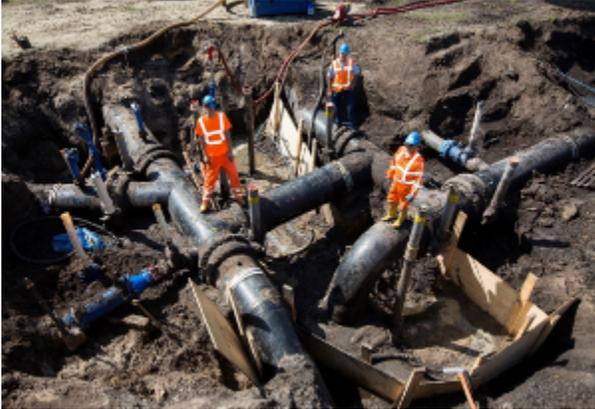
Subsidence can cause gas and water pipelines to break right where they enter houses. In the Netherlands, satellite data are used to monitor gas pipelines at affordable costs.

Satellite images show hot spots where ground movement is taking place. It thus allows a targeted replacement programme: the maintenance strategy has now become focused on areas of higher risk. Instead of replacing pipes and connections in a single district pipes serving individual houses or streets can be replaced.

In the past, companies like [Stedin](#) and [Oasen](#) have planned replacement programmes starting in areas where leaks have been previously reported and found to be due to subsidence. But a more targeted approach is possible using satellite images which show hot spots where movement is taking place. Satelliteborne Synthetic Aperture Radar (SAR) from the Sentinel-1 mission (part of the [Copernicus programme](#)) is used to identify where the ground is subsiding and TerraSAR-X (a commercial mission) is used to further pinpoint the movement more precisely which allows the maintenance strategy to become focused on areas of higher risk. Instead of replacing pipes and connections in a single district no matter the age or the actual risk of failure, a much more focused approach becomes possible where pipes which are at risk and serving individual houses or streets can be replaced.
